Your Inspection Report

3 Whitney Avenue
Toronto, ON M4W 2A7

INSPECTION DATE:
Tuesday, January 20, 2026

RE: Report No. 95871
3 Whitney Avenue
Toronto, ON
M4W 2A7

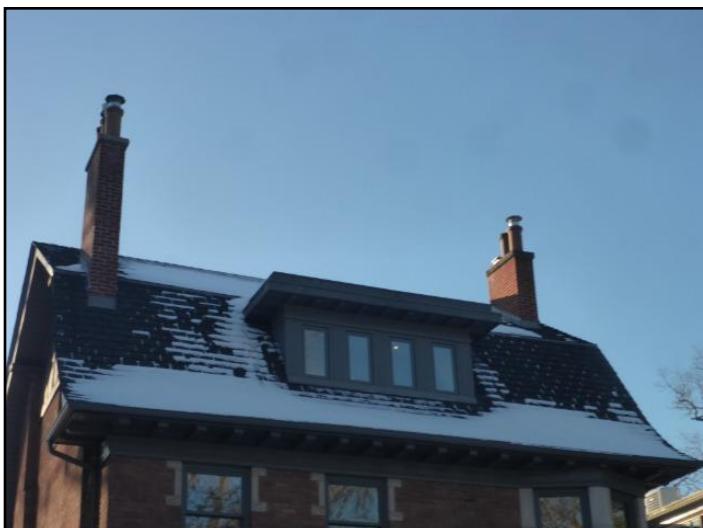
Condition: • The roof could not be inspected due to snow.

The roof could not be inspected due to snow.

Task: Further evaluation

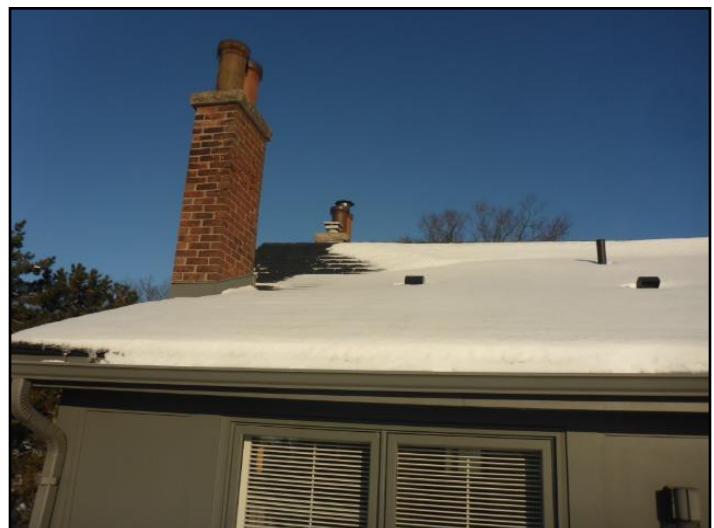
The roof could not be inspected due to snow.

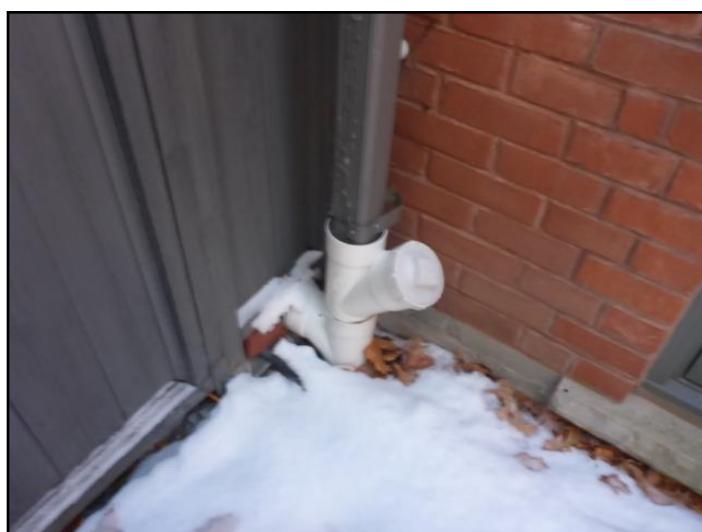
Condition: • Downspouts that discharge below grade may leak or be clogged, resulting in water in the basement or crawlspace.

Discharge below grade

Task: Re-direct downspouts to discharge above grade at least 6 feet from home.

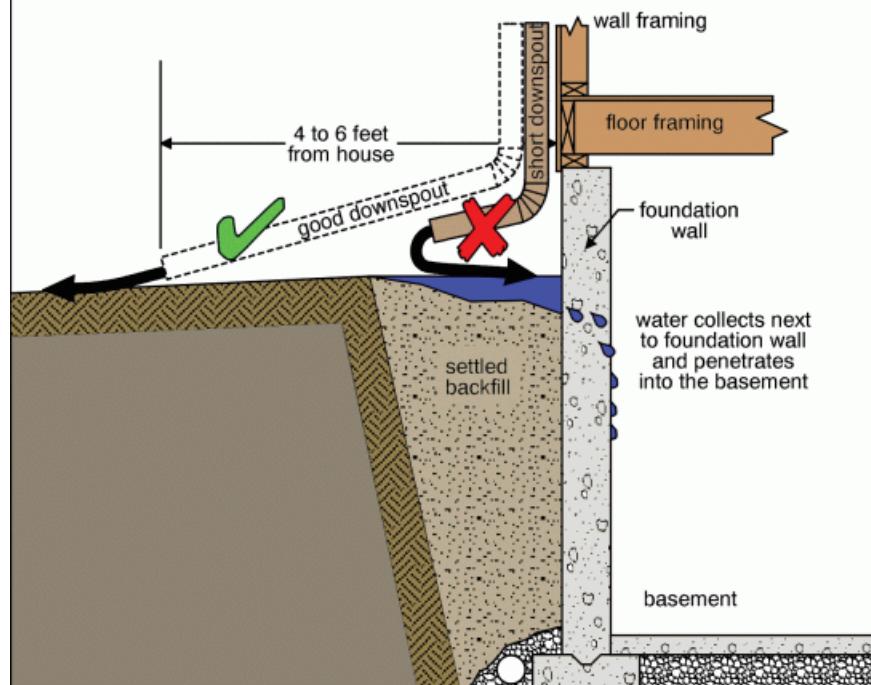
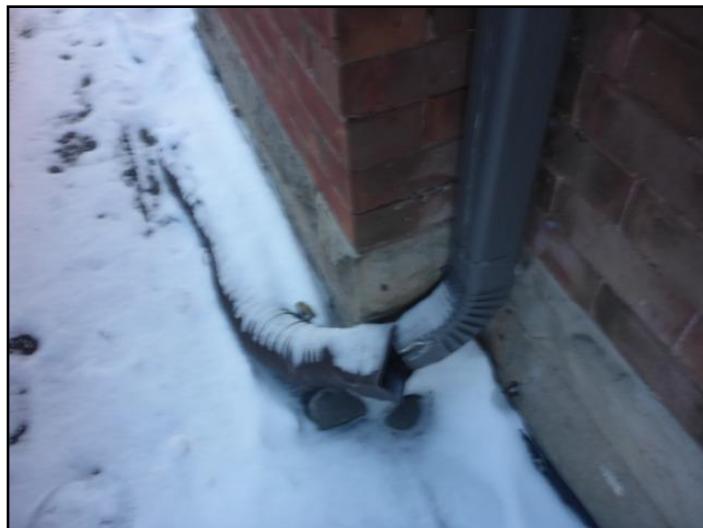
Condition: • Discharge too close to building

Downspout extension too short

Discharge too close to building

Always transfer water as far away from the house as practical. However attention to erosion, tripping hazard, or creating a slippery ice surface should also be considered.

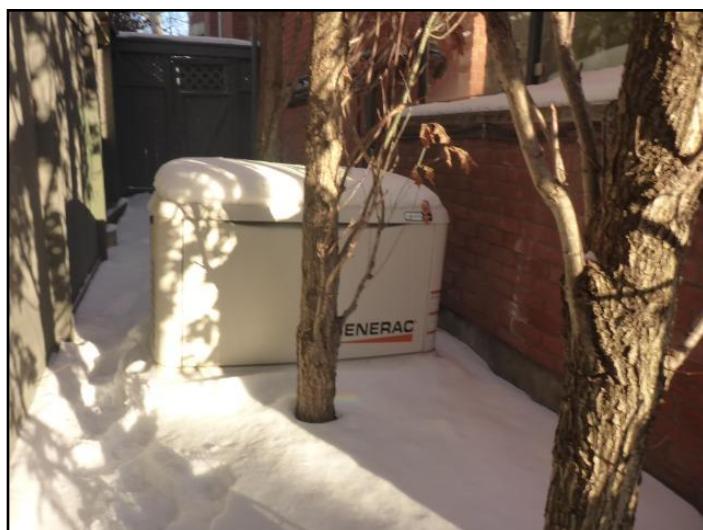
Condition: • Backup generator not tested/inspected

Generator not tested/inspected

Ask seller for details regarding how this equipment is set up and it is self-testing.

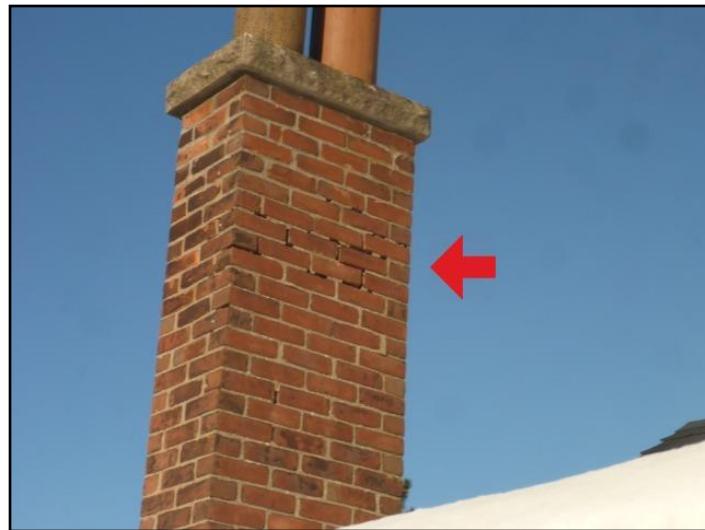
Condition: • Loose, missing or deteriorated mortar

Loose, missing or deteriorated mortar

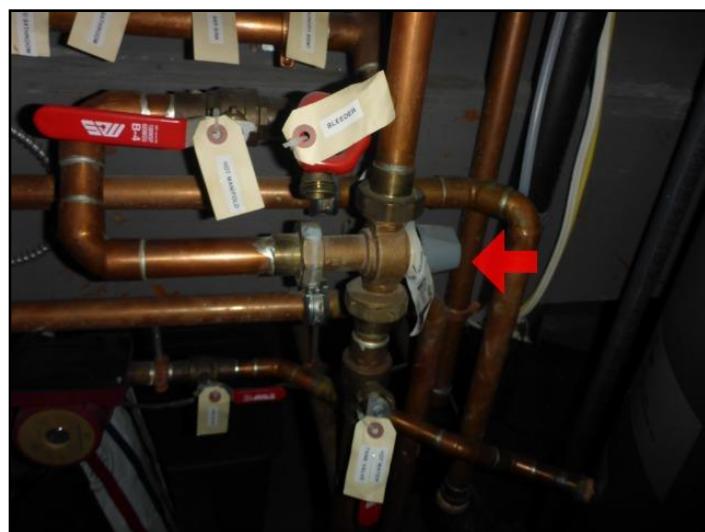
Condition: • Set improperly - above 120 degrees F (49 degrees C)

Tempering valve may need adjustment

Task: Adjust

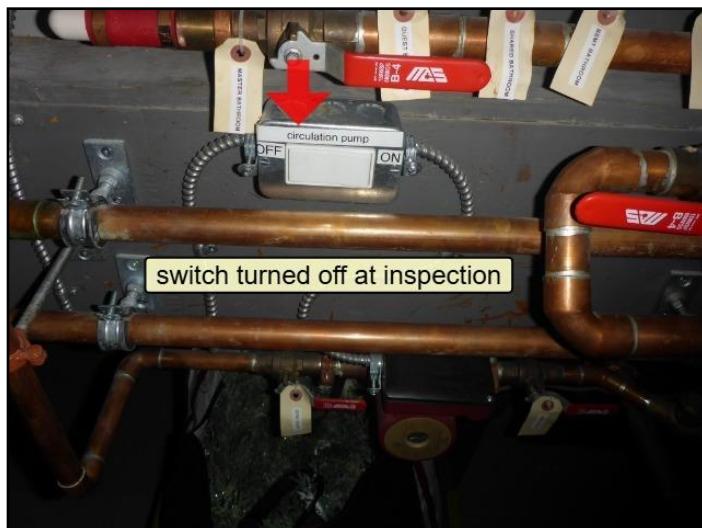
Condition: • Circulating pump turned off

switch for circulating pump

Installation of a timer on the circulating pump is recommended to reduce the wear and tear on the components.

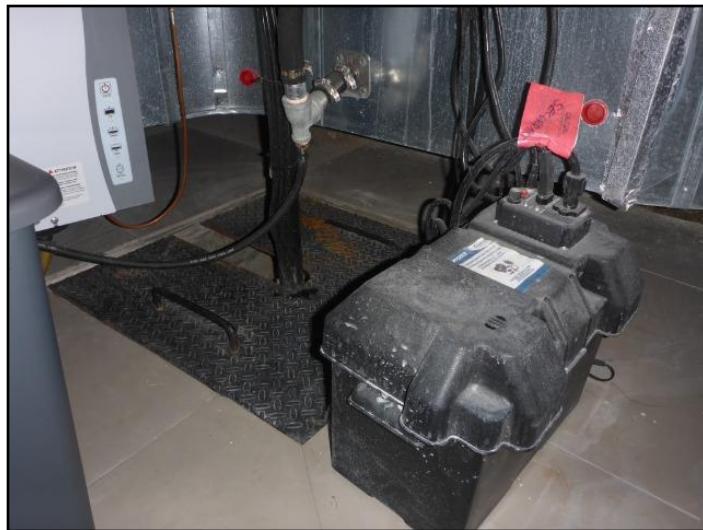
A battery powered backup pump was noted at the sump pit. Ask seller for details regarding the setup of this equipment.

Batter powered backup pump noted

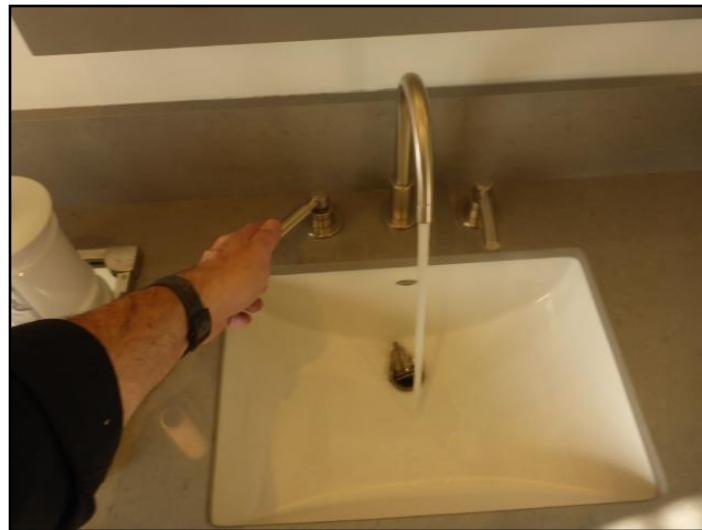
Condition: • Stiff or inoperative

Stiff hot faucet (left side sink)
