Your Inspection Report

3 Whitney Avenue
Toronto, ON M4W 2A7

INSPECTION DATE:
Tuesday, January 20, 2026

RE: Report No. 95871
3 Whitney Avenue
Toronto, ON
M4W 2A7

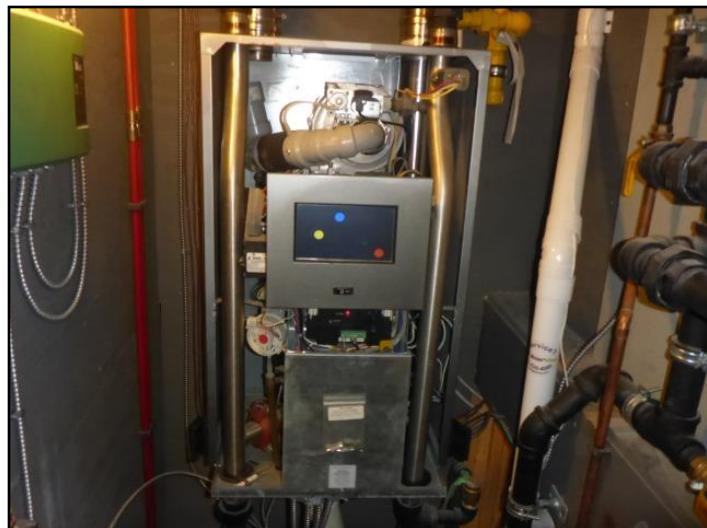
Boiler (basement utility room)

Condition: • At the time of inspection, the boiler was working properly and the house was comfortably warm. An annual maintenance agreement that covers parts and labour is typically recommended for all heating (and cooling) equipment.
